Patrick Erb - Home Inspection Services

*** Residential Inspection Report ***

Inspection Address

1044 County Highway 1

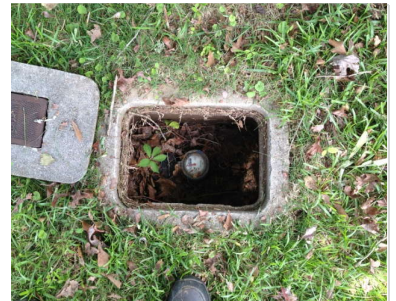
Static water pressure reading (psi): 120psi

Type of supply lines: Galvanized Pipe

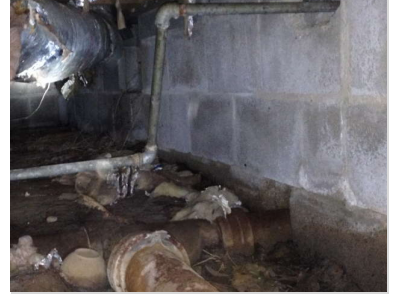
The main sewer line shows excessive rust. Exterior rust is high indication of interior rust. Consider budget to replace / upgrade structure plumbing supply and waste pipe.

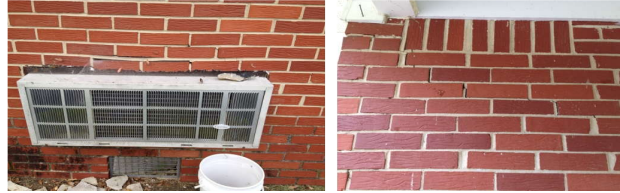
Further Comments: 1. The penetration cut for the through wall HVAC unit did not have a lintel installed to support the brick siding above. 2. To the right of the through wall hvac unit - at corner of car port - there is a settlement crack along mortar line Consider tuck pointing. Some additional tuck pointing is needed at others areas of siding but not a severe priority.

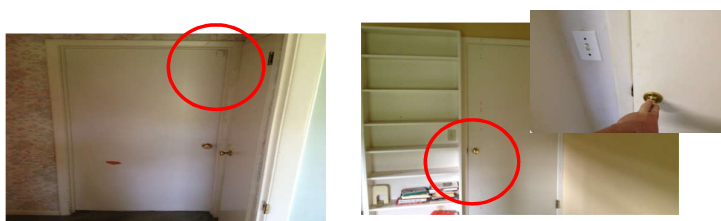
Further Comments: Left side front bedroom door and front center bedroom doors do not close completely within frame and or line up with door latch hardware. The door frame conditions are most likely due to settlement of block piers.

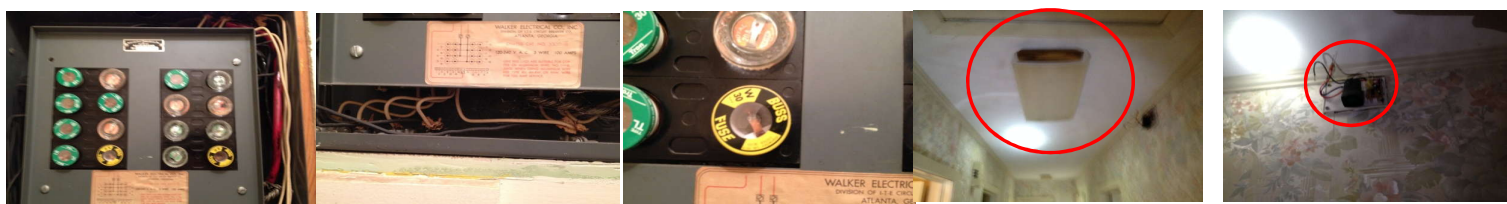
Further Comments: 1. Fuse panel is wired correctly for year built. Consider upgrade cost to circuit breaker panel IF interior is to be fully restored - short of re-wiring - replace current three prong plugs with GFI outlets to improve safety - 2 (pic 3) The 30 amp fuses should be replaced with 20 amp fuses for better circuit protection - pic 4 - Can not confirm operation of hall ceiling light fixture. Pic 5. Alarm siren for security system is damaged. Pic 6 - Security System Wiring Panel is located in rear corner bedroom closet. Please NOTE- Any outlet that has 3 prongs is NOT grounded - Home originally installed electric outlets would have been two prong outlets with no ground. Any of the replaced outlets w/ 3 prongs are not grounded. A best practice (short of upgrading entire electrical system and wiring) is to install a GFI outlet in areas where required for use of appliances that require a ground socket.

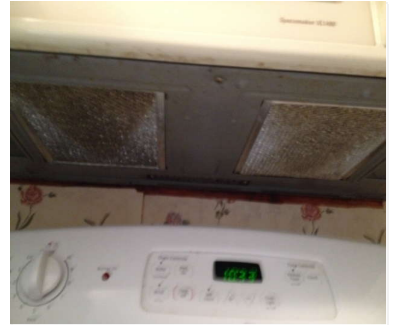
The vent system, filters and passages of vent installed in microwave should be dismantled and cleaned to remove grease / oil build up.

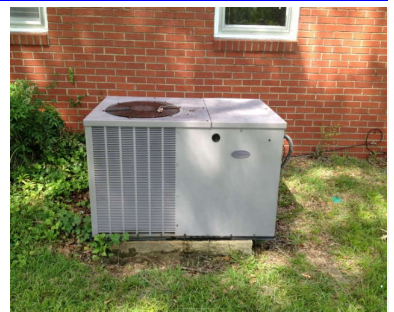
Suggest Service Call, unit cleaning - Please Note - Emergency Heat Function May not be installed in unit. Unit may be nearing end of lifespan.

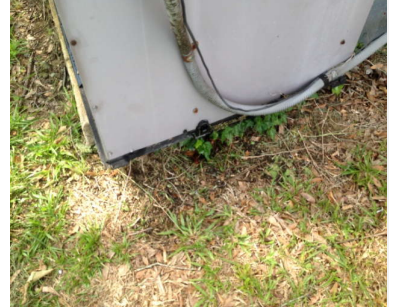
Condensation Tube Blocked - Bottom of Unit Rusted on interior

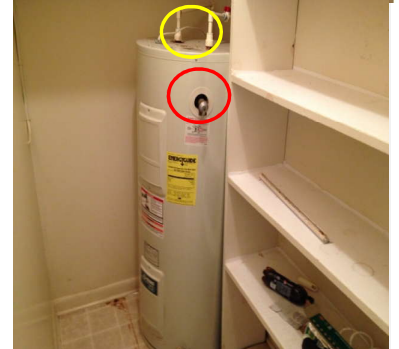
1. Supply Line Connections Rusted 2. A drain tube should be installed on the temp/pressure relief valve - unit is 14 years of age. 13-15 is average age of electric water heaters.
