Patrick Erb Home Inspection

Inspection Report

**8956 Bishop Ridge Road
West Blocton, Alabama 35184**

Inspection Date September 14, 2017
Client Mr. Sample Report
Inspector Patrick Erb
205-412-5256
erbhomeservices@gmail.com
Alabama Building Commission HI 3083, HUD - US Housing & Urban Development
H638, American Society Of Home Inspectors 251924

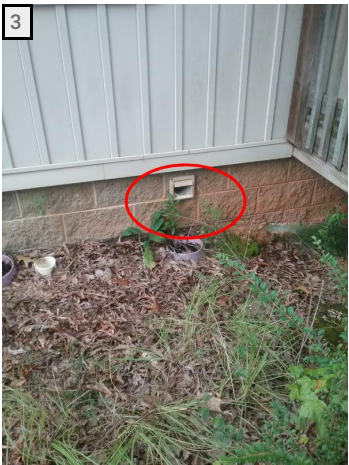
Dryer vent missing or damaged

Location	Exterior: Ground View
Impact	Dryer should vent to the exterior
Suggested Action	Replace missing or damaged vent piping

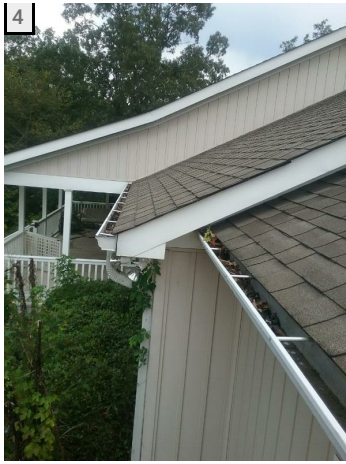
In need of cleaning

Location	Exterior: Ground View, Exterior: Roof View
Impact	The gutters may clog causing water to overflow and run down fascia board, potentially wearing wood before its time
Suggested Action	Clean the gutters

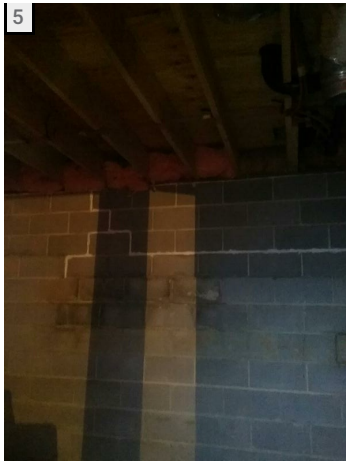
⚠ Foundation Wall

Exhibits moderate step cracks

Location	Basement
Impact	Evidence of potential differential settlement
Suggested Action	Additional inspection by a structural engineer and/or foundation repair service is recommended. The settlement cracking of the foundation may be in need of improvement
Other Information	If additional concerns were noted such as settlement cracking of drywall, binding doors, off level flooring conditions or other have been noted in the report - then it is Highly Recommended to obtain additional inspection

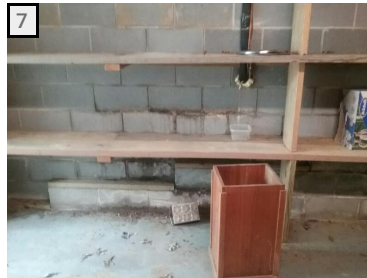
Dark stains on the interior of foundation walls

Correction needed before basement completion is performed

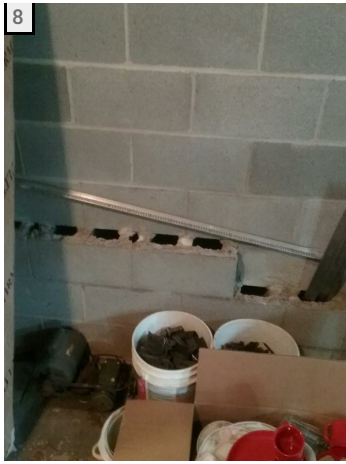
Open voids in block

Location	Basement
Impact	Allows moisture to enter interior
Suggested Action	Seal prior to basement completion of the interior of the basement space.

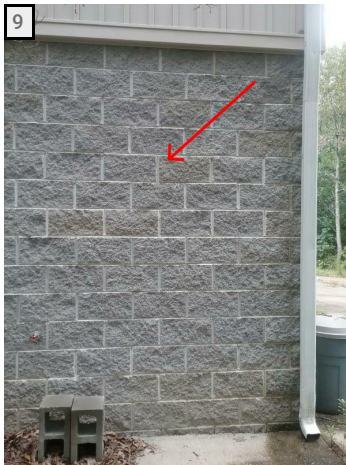
Exhibits hairline step cracking

Location	Exterior: Ground View
Impact	The cracking may worsen allowing moisture intrusion
Suggested Action	Monitor for further cracking. If the cracks widen have repaired by a licensed waterproofing contractor

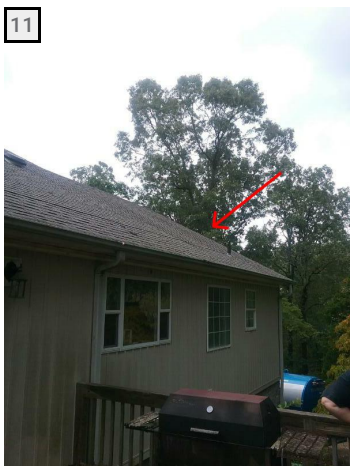
Dips and sagging of roof deck found

Location	Exterior: Roof View
Impact	May create opportunity for leaks, poor run off of rain and debris in time and/or reduce effective wind load
Suggested Action	Consider obtain 2nd opinion from a qualified building contractor and/or structural engineer.

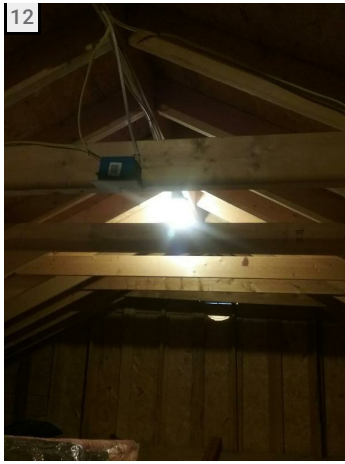
Additional photo of roof / attic framing

Location	Exterior: Roof View
Impact	Wavy condition found on exterior roof deck
Suggested Action	Recommend obtain a 2nd opinion from a qualified building contractor or structural engineer

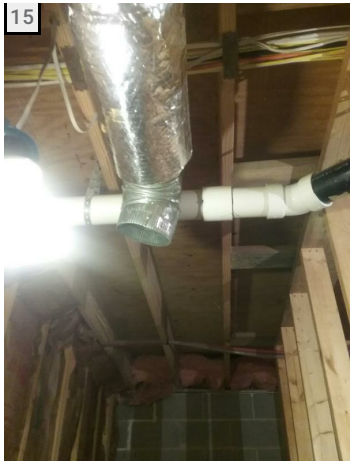
Vent cover / regulators are missing

Location	Basement
Suggested Action	Shut off HVAC vents for basement until restoration is complete

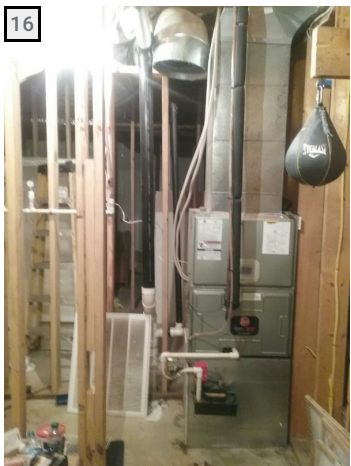
Open return

Location	Basement
Suggested Action	All returns should be filtered. 2 return in basement should be sealed until completion of walls and ceilings

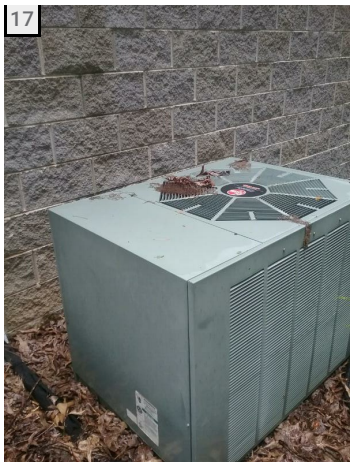
A Preventative - Repair or Maintenance service call is needed

Location	Exterior: Ground View
Impact	Unit may have been somewhat functional or below common standards.
Suggested Action	Obtain a complete service check to ensure proper functioning of unit. Request service records.

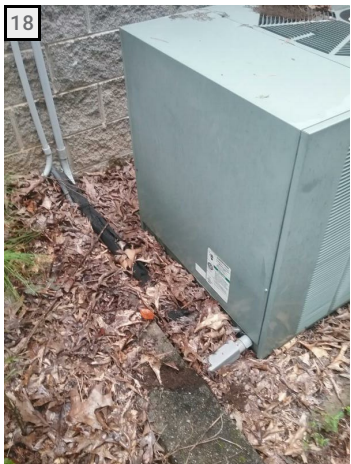
Insulation is missing or damaged

Suggested Action Replace the current freon line insulation w/ pipe wrap or add missing section

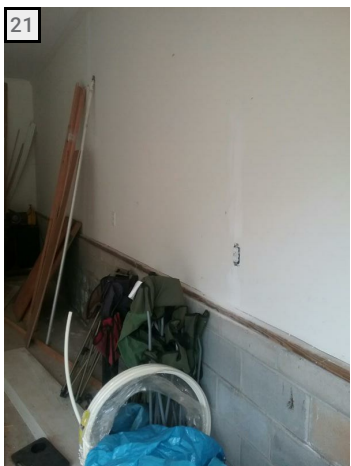
Cover plate is missing

Location	Attached Garage
Impact	Without a cover plate, can cause electrical shock if touched
Suggested Action	Install a cover

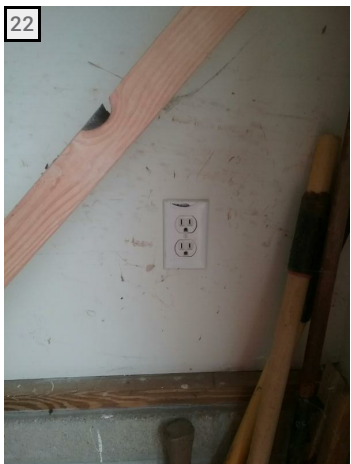
Cover is cracked

Location	Attached Garage
Suggested Action	Replace the cover

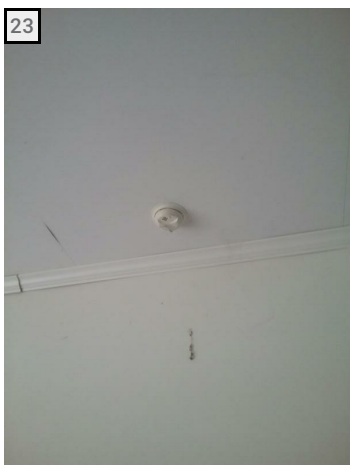
Not Working

Location	Attached Garage
Suggested Action	Replace the smoke detector

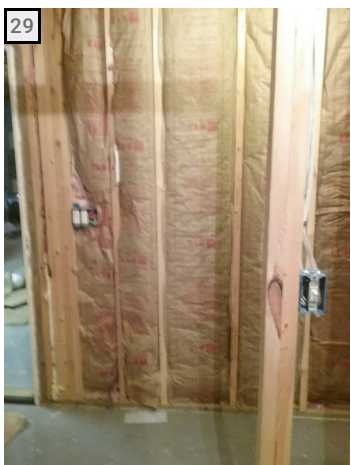
Cover is missing

Location	Basement
Impact	Without a cover plate, can cause electrical shock if touched
Suggested Action	Install a cover
Other Information	The electrical system in the lower level is in need of completion. Rough electrical was found to be incomplete during the inspection.

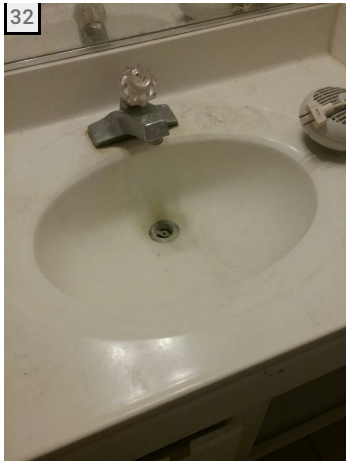
Drain stop is missing

Suggested Action Replace the drain stop

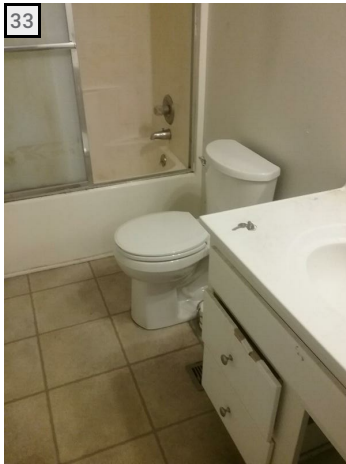
A - Tank Hardware Repair is needed

Location	2nd Bathroom
Impact	Not functioning as intended and/or components showing wear
Suggested Action	Repair needed - replace effected tank hardware
Other Information	When the water supply is off for an extended period of time seals and washers may shrink and crack.

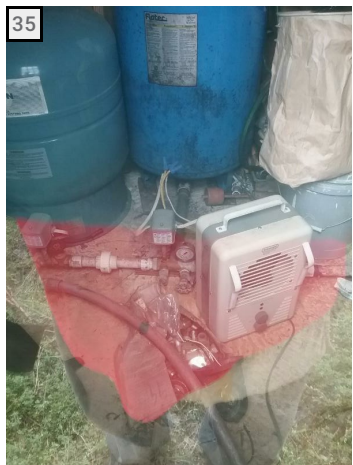
Open wiring

Location	Exterior: Ground View
Suggested Action	Install within protective Junction box

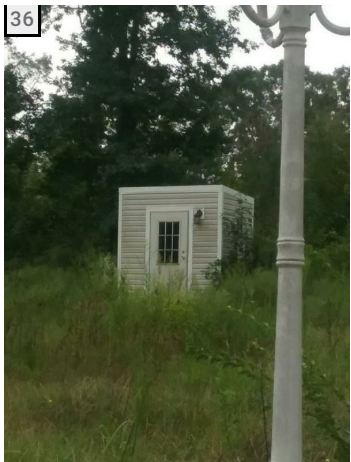
Additional information needed

Location	Exterior: Ground View
Impact	Purpose unknown
Suggested Action	Request additional information as to the use and operation of the well

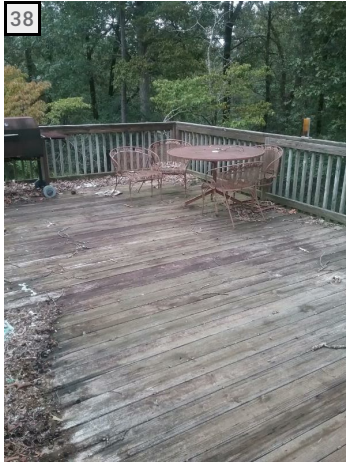
Stain, paint or sealer has peeled, faded or bleached out

Location	Exterior: Ground View
Impact	Without sealer, the wood is not protected from the elements
Suggested Action	Restain and/or reseal with a weather resistant sealer

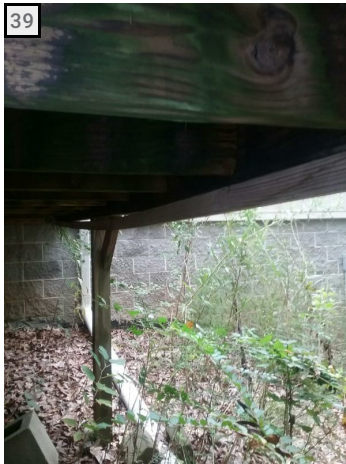
Ledger Board Loose

Location	Exterior: Ground View
Impact	Supports joist frame
Suggested Action	Attach with fasteners. Rear deck

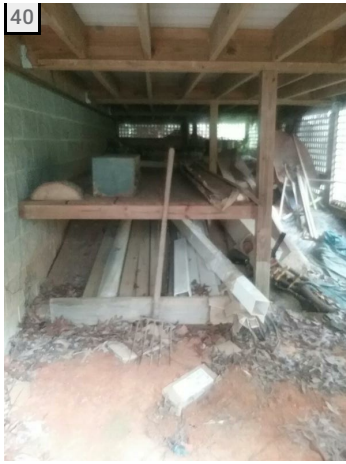
Under front deck

Wood is in contact with soil

Location	Exterior: Ground View
Impact	The soil may cause moisture damage to the wood
Suggested Action	Monitor for wood deterioration. Should deterioration continue have repaired or replaced

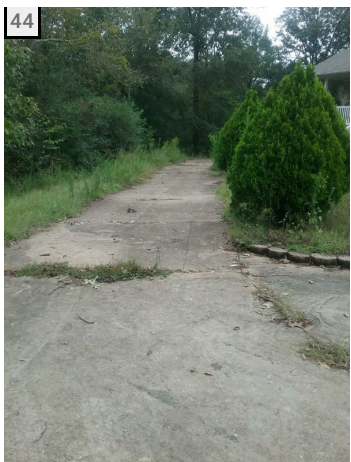
Concrete is settling with minor cracks

Location	Exterior: Ground View
Impact	The cracks allow for water intrusion, which may cause the surrounding surfaces to also deteriorate possibly requiring a complete driveway replacement
Suggested Action	Seal the crack(s) with weather-resistant pliable concrete sealer

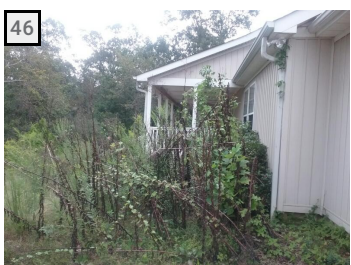
Shrubbery is in contact with home or siding

Location	Exterior: Ground View
Impact	The shrubbery provides an environment where moisture and/or insects could intrude
Suggested Action	Regularly trim the shrubbery to achieve a clearance of at least 6 - 8 feet

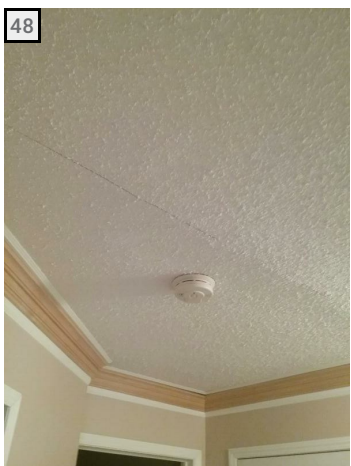
Drywall seam and/or settlement crack - cosmetic

Location	Hallway and Stairs
Impact	Cosmetic - may be due to minor building settlement
Suggested Action	Consider cosmetic repair and paint - monitor conditions

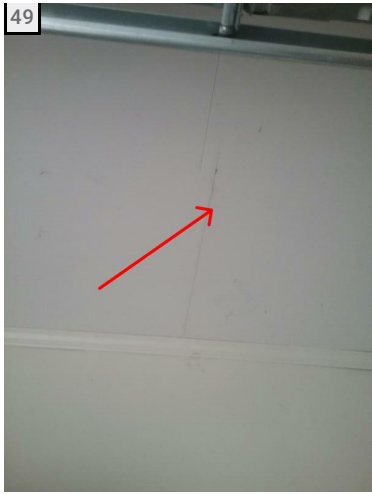
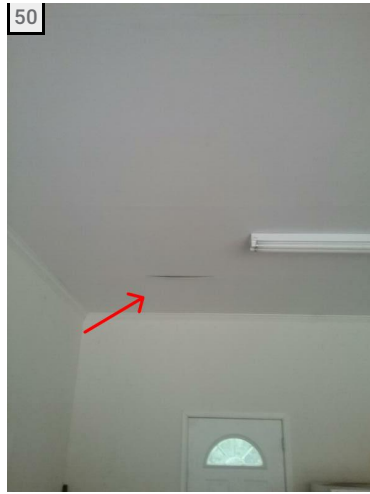
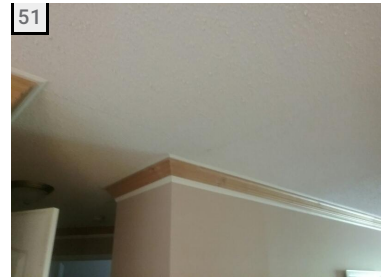
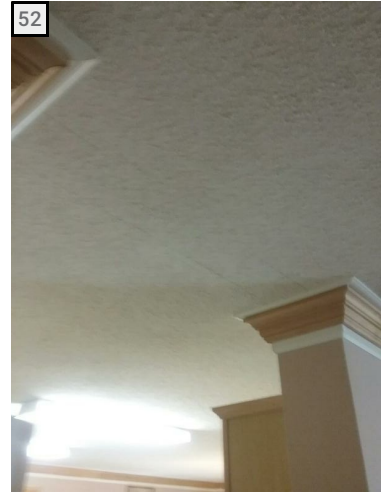
Drywall tape at seam or joint has separation

Location	Attached Garage, Kitchen, Living Room
Impact	With separation, the wall lacks asthetic appeal
Suggested Action	Remove the drywall tape, reapply new tape and drywall compound. Once repaired, manage the humidity levels in the home such that moisture levels are in the range of 35% to 50%

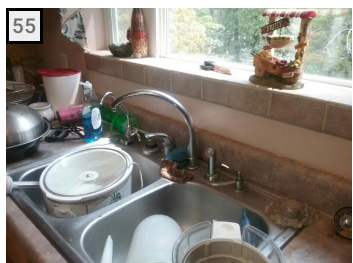
Sealant has deteriorated

Location Kitchen
Suggested Action Replace where needed

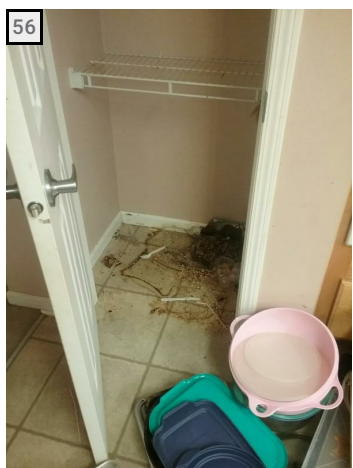
Vinyl is damaged

Location Kitchen
Suggested Action Replace the damaged section

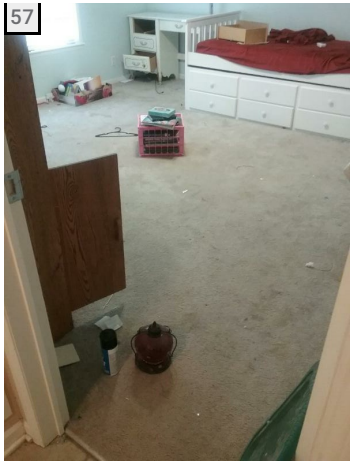
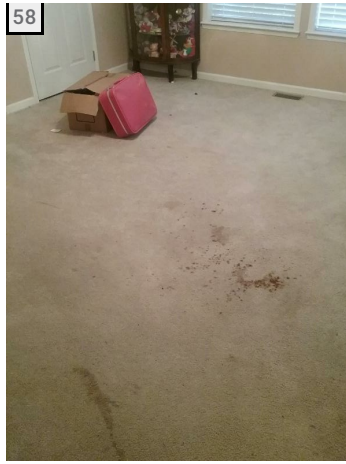
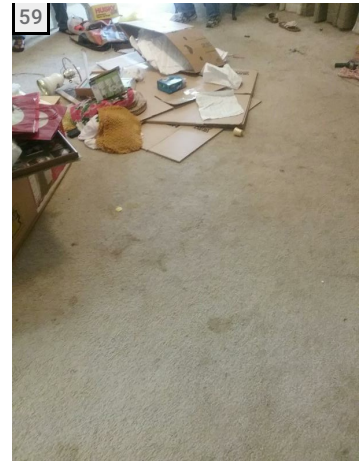
Stain on carpet

Location Living Room, 2nd Bedroom, 3rd Bedroom
Suggested Action Consider cost of cleaning or replacement

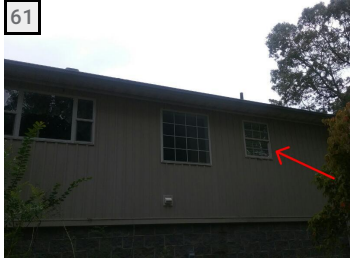
Missing

Location Exterior: Ground View
Impact Should the window be open, lacks protection from insects
Suggested Action Consult with seller to identify if screens exist. If they do not, install screens as needed

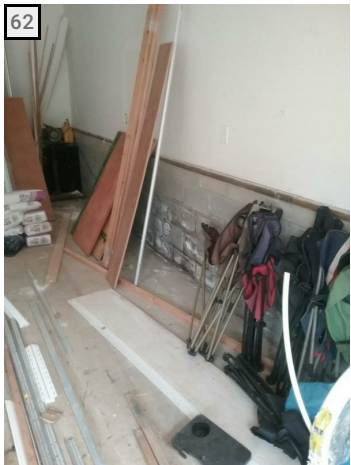
Dark stains similar to fungi

Location Attached Garage
Impact May be due to moisture intrusion
Suggested Action Find and correct source of moisture and make cosmetic repairs
Other Information Could be due to clean door conditions

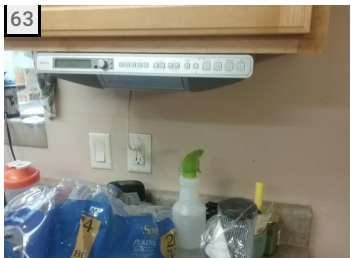
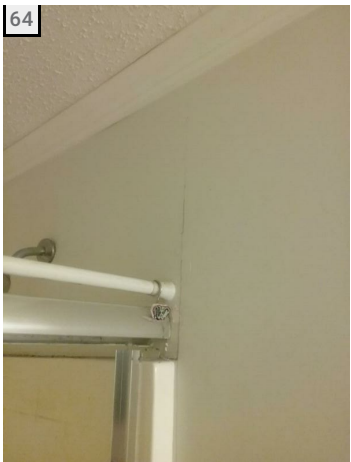
Drywall has settling cracks

Location Kitchen, 2nd Bathroom
Impact Potential symptom of foundation settlement
Suggested Action Consider obtain 2nd opinion from a qualified building contractor and/or structural engineer.
Other Information Settlement cracks may be an indication of foundation settlement

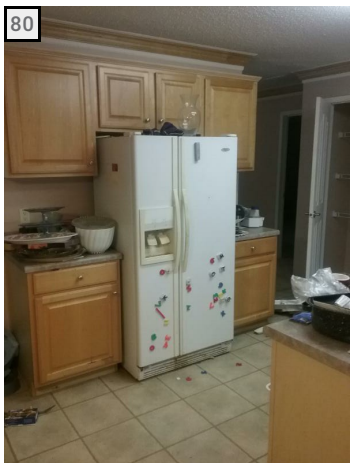
Budget to replace or disinfect

Location	Kitchen
Suggested Action	May not function well in current condition

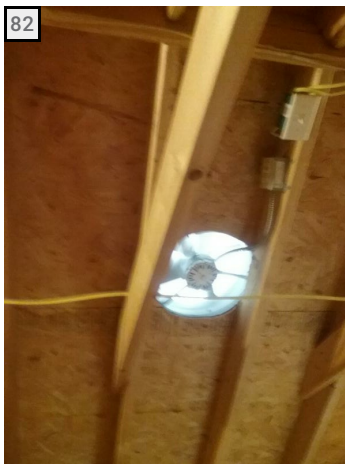
Poor Attic Ventilation

Location	Attic
Impact	Poor attic ventilation may damage roof covering, roof decking materials. Expansion during high heat build up may occur. Warping of roof deck may occur.
Suggested Action	1. Remove and clean soffit vents openings for improved air flow. 2. Increase exit ventilation A: Increase ridge venting net free space Or B: Seal Ridge Venting and install Turbine or Thermostat Controlled attic vent fan. Minimum ratio to achieve is to provide 1 sq. ft. of net free attic ventilation per every 150 sq ft of linear attic space. The ratio should be split between air entry via soffits and air exit via roof top venting.

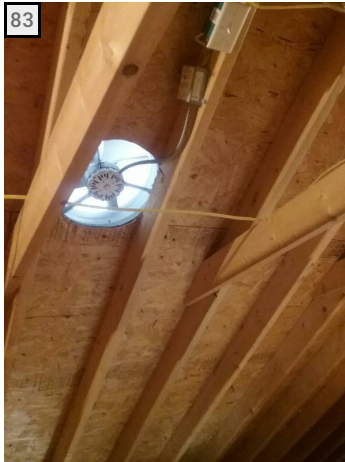
Attic fan not working

Location Exterior: Roof View
Suggested Action Check, repair or replace

There are three that need to be replaced 3 for 3.

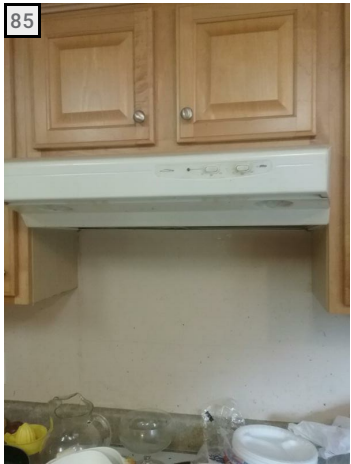
Past intended lifespan

Location	Kitchen
Suggested Action	Consider replacement
