*** Residential Inspection Report ***

Date Of Inspection: August 6th 2016
Inspection Address: 123 Inspected Home, Jasper AL 355XX

Residential, Mod. Garden, Concrete Slab Found.

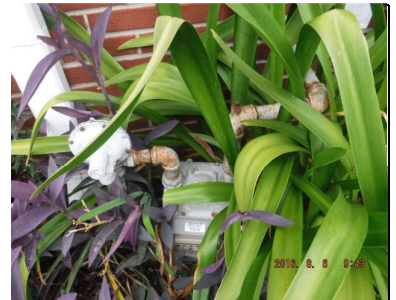
Gas

Supply for furnace and Water Heater.

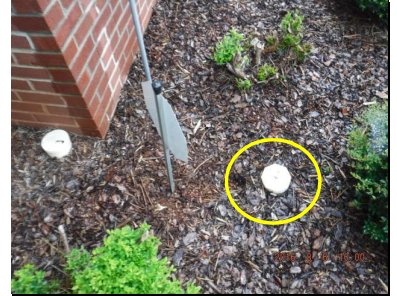
Sewer Main Line exits toFront No backups or negative conditions found during inspection.

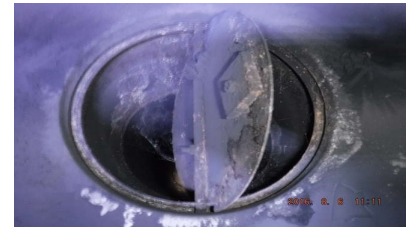
Further Comments: * Damper operational - cleaning needed - Metal Damper

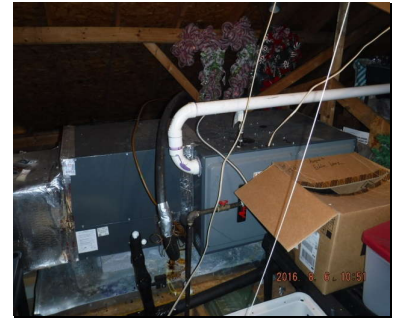
Location Attic Space

Brand: Goodman **Year Model** 2010
Model# CHPF3642C6CA **Serial#** 1007663142
Type Split System -Gas Furnace and A/C Air Handler

1. Unit in need of general / preventative maintenance - Temperature differential indicates basic maintenance need. 2. Unit functional on A/C and Heat Mode - Preventative maintenance needed.

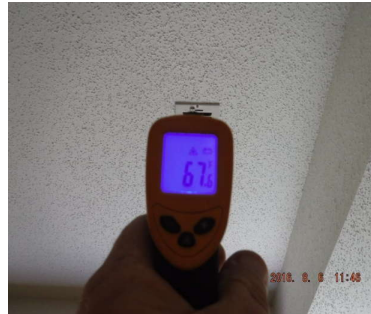
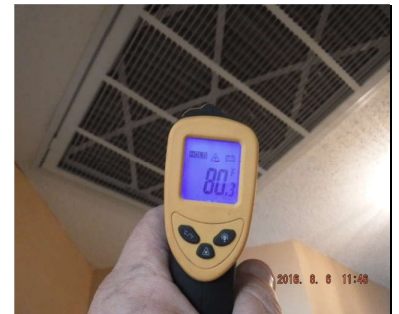
Type Metal Main, Flex Branch

1. Consider preventative maintenance of HVAC to attempt to improve temperature differential to target range of 15-20F on A/C and to balance output of air and temperature at vent for more even distribution.

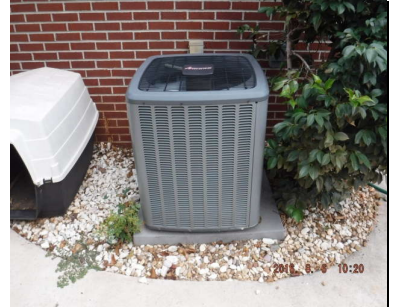
1. Unit Functional 2. Based on lower than common range temperature differential of vent output- Preventative maintenance needed i.e. 19 point service check. - Note- unit may still have some remaining warranty

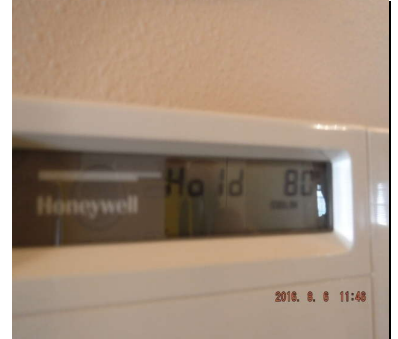
Additional information needed in re: thermostat control operation.

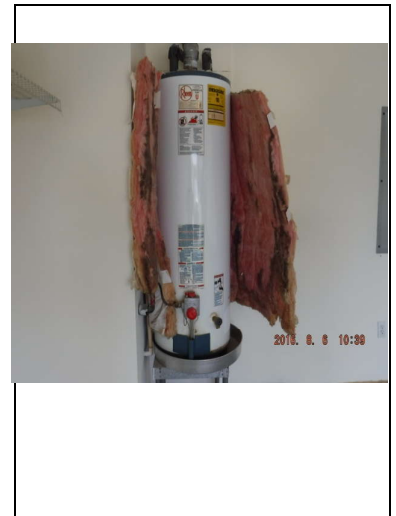
1. Unit Functional 2. Unit is Past Intended Lifespan 3. Average lifespan range for gas water heaters 15-18yrs of age.
