Patrick Erb Home Inspection

Inspection Report

**8956 Bishop Ridge Road
West Blocton, Alabama 35184**

Inspection Date September 14, 2017
Client Mr. Sample Report
Inspector Patrick Erb
205-412-5256
erbhomeservices@gmail.com
Alabama Building Commission HI 3083, HUD - US Housing & Urban Development
H638, American Society Of Home Inspectors 251924

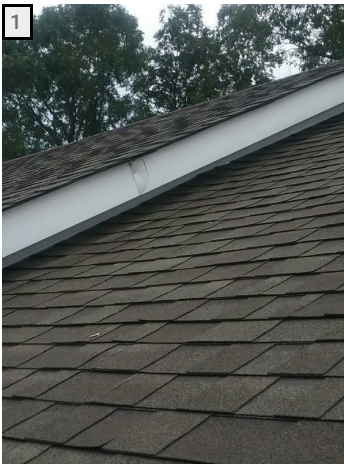
Painting needed

Location	Exterior: Roof View
Impact	All components should be protected from exposure
Suggested Action	Prep and paint or wrap with trim such as vinyl or metal

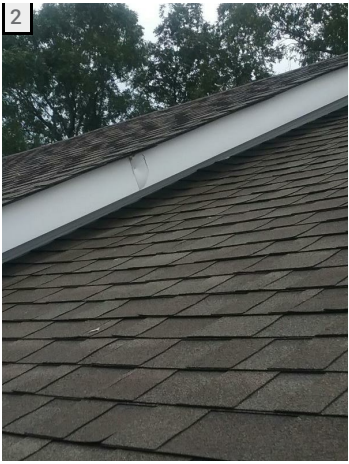
General Maintenance needed - clean, prep & Paint

Location	Exterior: Roof View
----------	---------------------

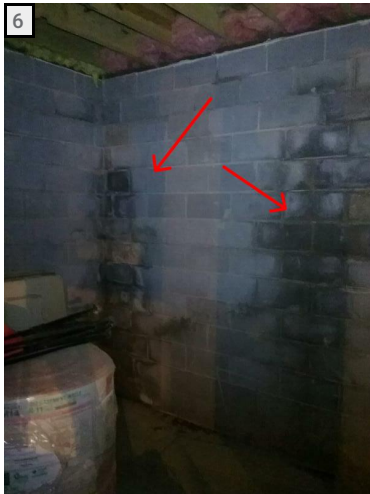
28. Foundation Wall(Basement): Dark stains on the interior of foundation walls

Dark stains on the interior of foundation walls

Location	Basement
Impact	Poor exterior drainage may allow water entry into the crawlspace or basement
Suggested Action	Improve exterior grade, drainage run off of surface water. introduce drainage swales, increase sloping or install a subsurface drain for flat, poorly drained areas.
Other Information	See the More Information links for helpful information

Correction needed before basement completion is performed

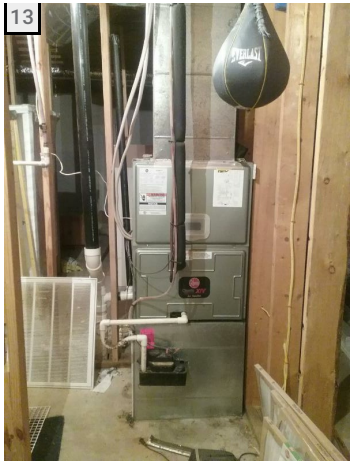
Obtain comprehensive service check needed

Location	Basement
Suggested Action	Budget for repair and near future replacement

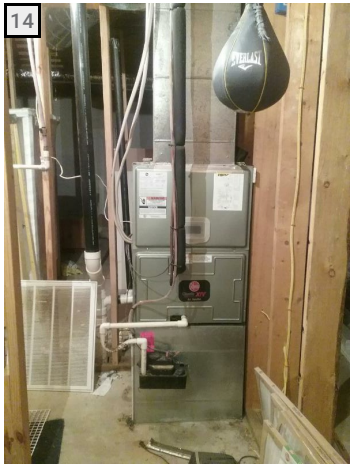
Request service history needed

Location	Basement
Suggested Action	Obtain date and ppwk of most recent service

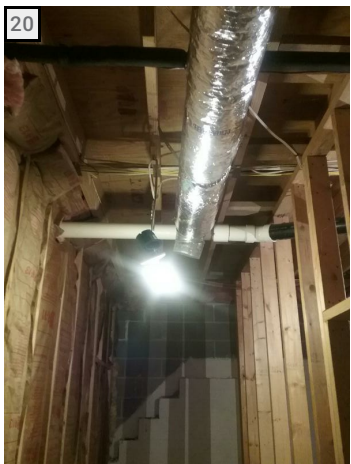
Unfinished

Location	Basement
Suggested Action	Budget for completion

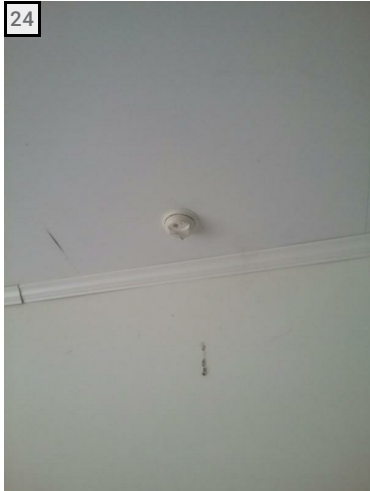
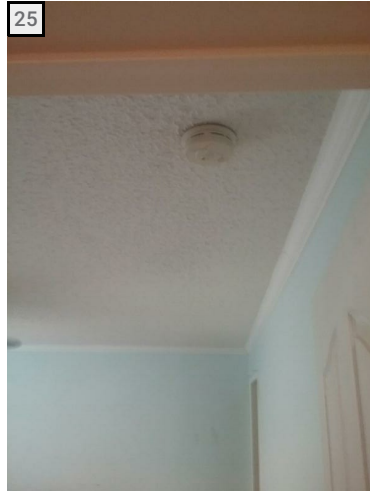
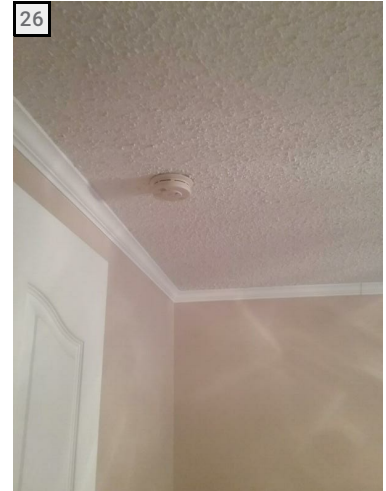
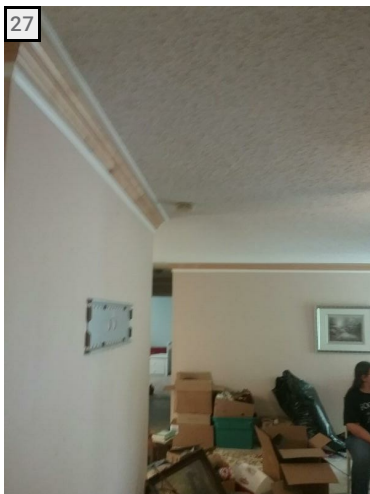
- 49. Light Fixture(Basement): Unfinished
- 50. Outlet(Basement): Unfinished electrical installation
- 51. Smoke Alarm(Attached Garage, Basement, Living Room, 2nd Bedroom, 3rd Bedroom): Replace backup battery
- 52. Wiring(Basement): Unfinished

Replace backup battery

Location Attached Garage, Basement, Living Room, 2nd Bedroom, 3rd Bedroom

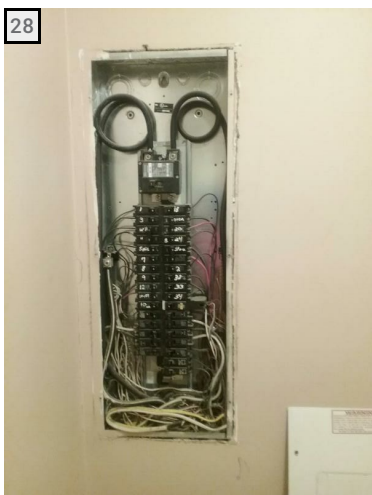
functional during inspection

Appears Functional - Appears to be installed in locally accepted manner for year built.

Location Laundry Room / Mudroom

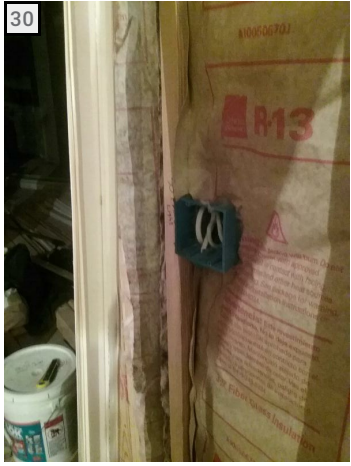
Unfinished

Location	Basement
Suggested Action	Budget for completion

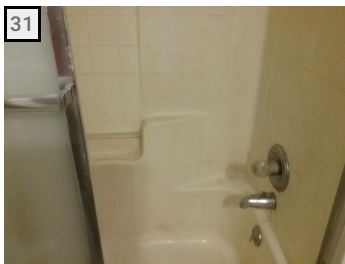
Impact Permanent staining of tub or shower units may require extensive repair or resurfacing needs.

Suggested Action Thoroughly clean as needed Budget for cosmetic improvement

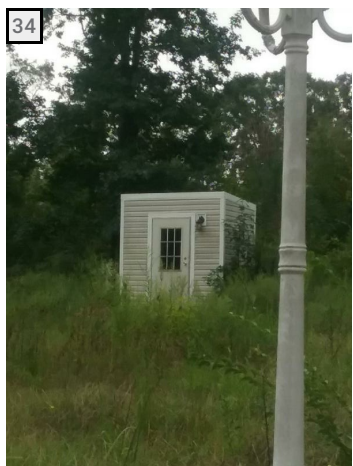
Not working

Location	Exterior: Ground View
Suggested Action	Have repaired by a qualified well contractor

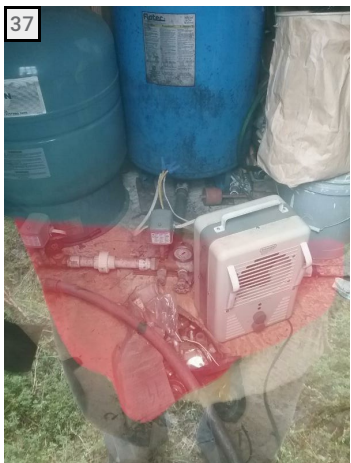
- 53. Pressure Tank(Exterior: Ground View): Not set up for function
- 54. Sink(2nd Bathroom): Drain stop is missing
- 55. Well(Exterior: Ground View): Not set up for function during inspection

Not set up for function during inspection

Location	Exterior: Ground View
Suggested Action	Consider request additional information

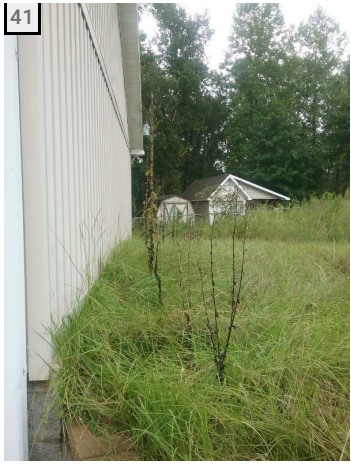
Right side

Does not have a positive grade

Location	Exterior: Ground View
Impact	Directing more moisture towards the foundation increases the risk of moisture intrusion
Suggested Action	Monitor the area for moisture buildup. Should it arise, If possible, regrading the area to achieve a slope away from the home. If regrading is not possible, add drain tile to re-direct water away from the home. Also, consult with a licensed waterproof (...)
Other Information	Water should be directed away from all standing foundations to prevent potential water intrusion. The drainage strategy of the foundation is important. Expansive soils can be very destructive to the foundation if the moisture content of the perimeter varies

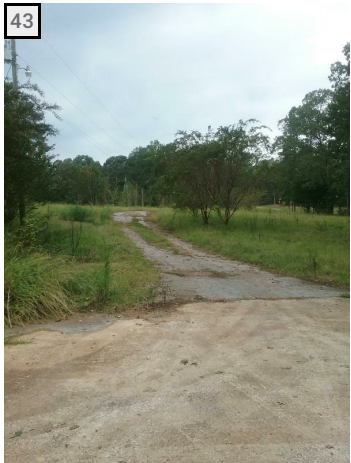
Grading and drainage improvement needed

Location	Exterior: Ground View
Impact	Poor surface with ditching
Suggested Action	Grade, crown, ditch and add gravel where needed

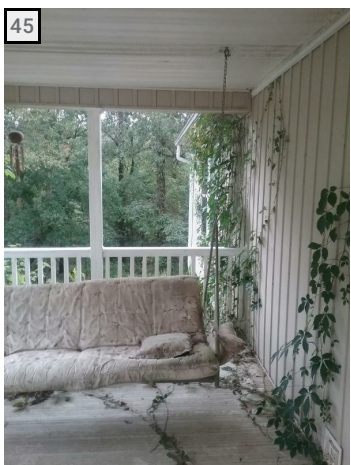
Ivy growth on exterior walls

Location	Exterior: Ground View
Impact	The ivy could cause deterioration to siding and potential of insect infiltration
Suggested Action	Remove the ivy

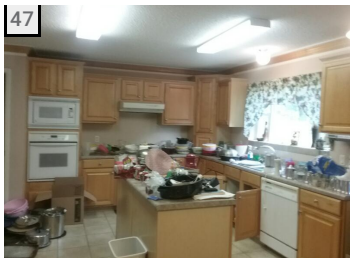
63. Countertop(Kitchen): Sealant has deteriorated

Cosmetic - Clean, prep and seal needed as general maintenance item

Location Kitchen

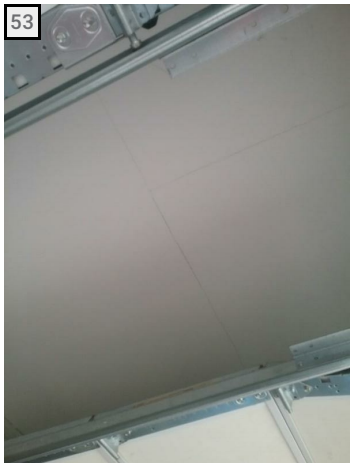
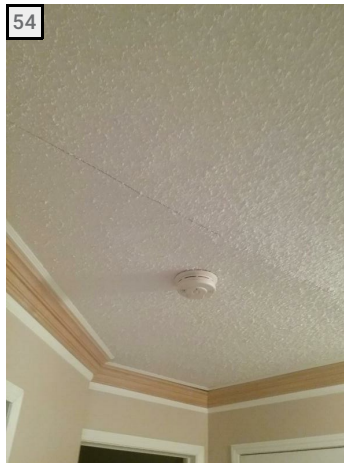
62. Ceiling(Hallway and Stairs): Drywall seam and/or settlement crack - cosmetic

Drywall seam / Minor settlement

Location	Attached Garage, Hallway and Stairs
Impact	Cosmetic and/or due to minor building settlement
Suggested Action	Consider cosmetic repair and paint - monitor conditions

Marriage wall seam

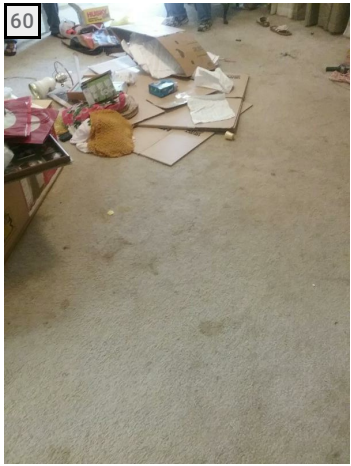
Carpet is old and shows signs of wear and discoloration.

Location Living Room

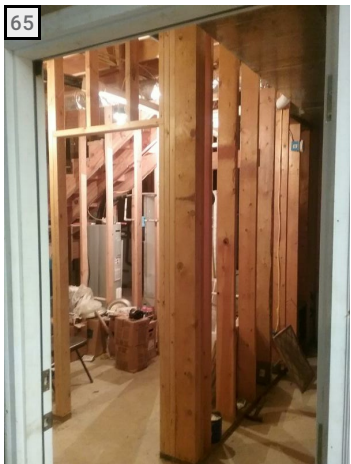
Unfinished

Location Basement
Impact Budget for completion

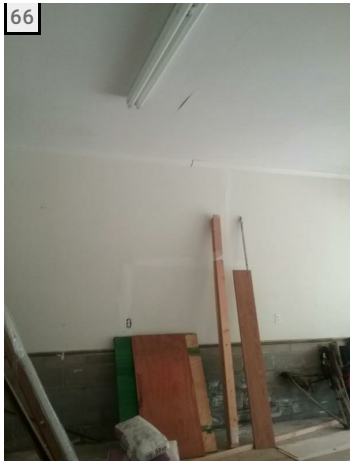
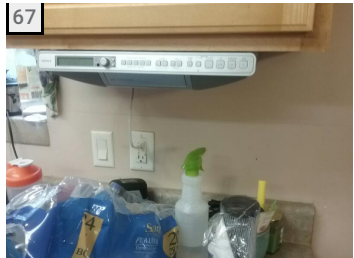
13. GFCI(Attached Garage, Basement, Laundry Room / Mudroom): Not present

Drywall tape at seam or joint has separation

Location Attached Garage, Kitchen
Impact With separation, the wall lacks asthetic appeal
Suggested Action Remove the drywall tape, reapply new tape and drywall compound. Once repaired, manage the humidity levels in the home such that moisture levels are in the range of 35% to 50%

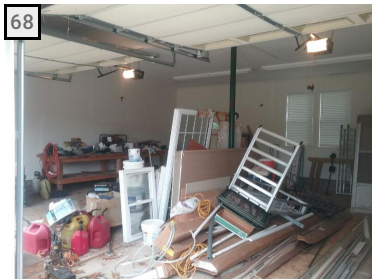
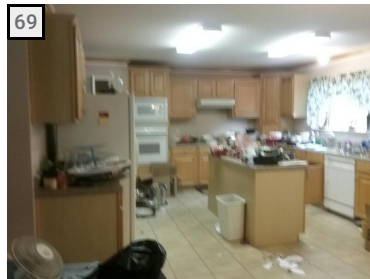
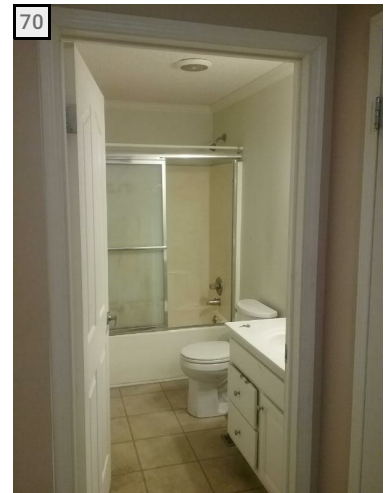
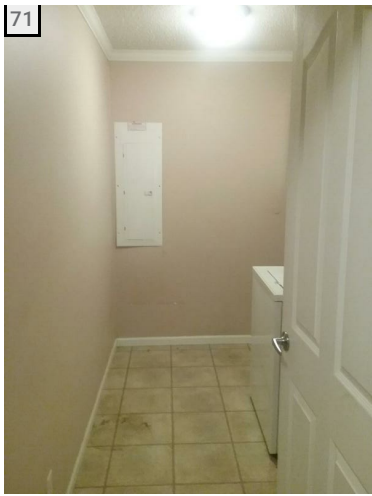
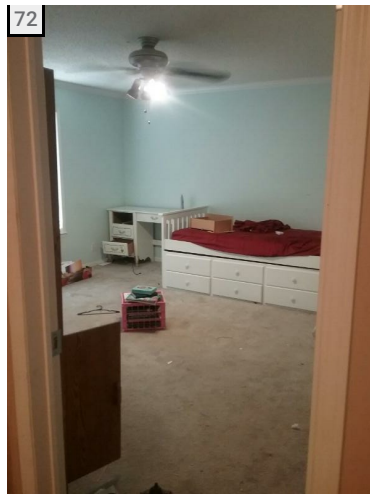
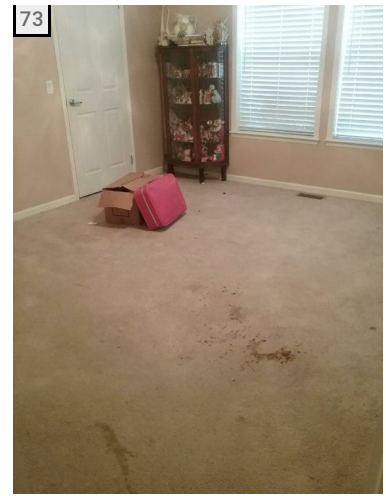
An example photo - Room condition

Location	Master Bathroom, Master Bedroom, Attached Garage, Kitchen, Laundry Room / Mudroom, Living Room, 2nd Bathroom, 2nd Bedroom, 3rd Bedroom
Impact	General condition is fair or may be in need of cosmetic improvement if desired
Suggested Action	Photo provided as an example of conditions found during the inspection - Consider cosmetic improvement as desired
Other Information	Consider the budgeted cost of improvement prior to purchase. Even if performing remodeling yourself, material costs should be estimated and included in the cost of purchase.

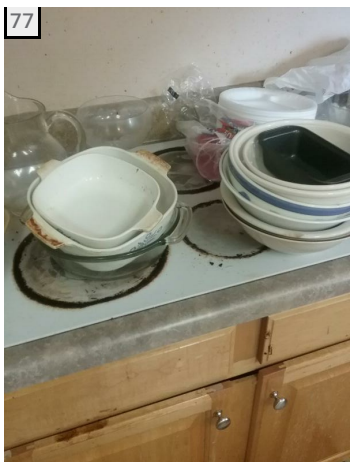
Nearing the end of its useful life

Location	Kitchen
Suggested Action	Budget for a newer unit. In the interim, a higher level of maintenance can be expected

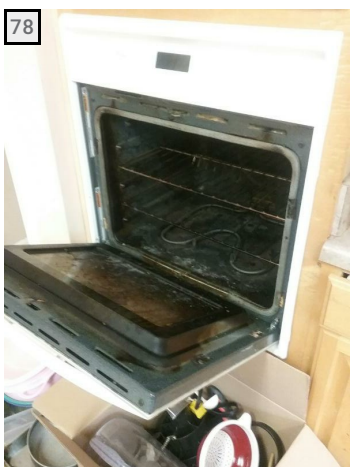
Not functioning as intended

Location	Kitchen
Impact	Can not confirm. There is power via outlet, unit is not working
Suggested Action	Correction or service needed

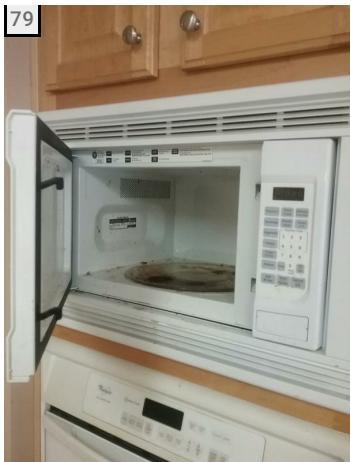
24. Refrigerator(Kitchen): Budget to replace or disinfect

Not Working

Location	Kitchen
Suggested Action	Replace the unit as desired or attempt cleaning. Unit is very stained (interior)

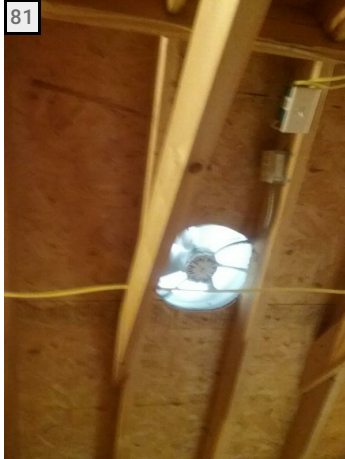
Not operating

Location	Attic
Impact	With an inoperative vent, there is significantly less volume of hot air being exhausted and humidity being eliminated from the home
Suggested Action	Replace the vent - All three vent fans in need of replacement

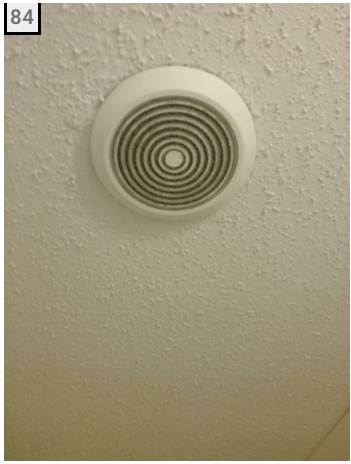
Does not exhaust to exterior

Location 2nd Bathroom, Attic
Impact When exhausting to the interior, humidity or other particulates are not expelled from the home increasing health risks
Suggested Action Re-route the exhaust to exit to the exterior using an exterior wall or roof vent

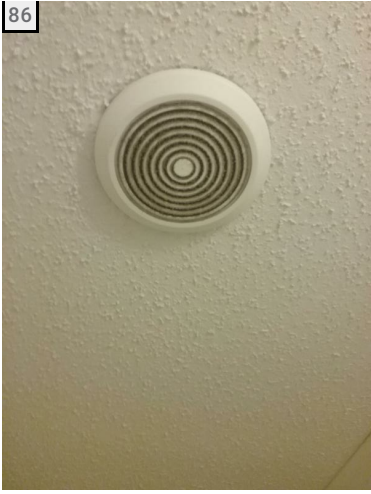
Location	2nd Bathroom
----------	--------------

Clean exhaust vent covers - General Maintenance Need - Dust and debris may overheat fan motor.
